Summary of EPA Surface Water Sampling of Select Metals Results to Date

Gold King Mine Blowout

August 7, 2015

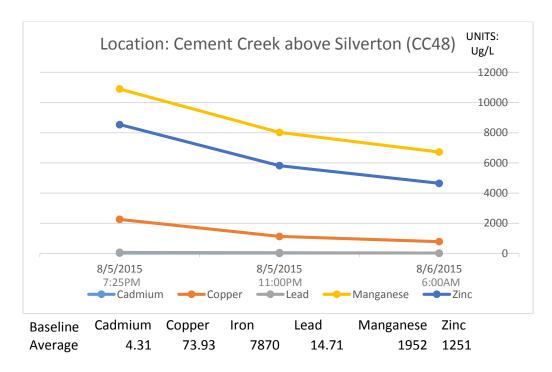
The first graph provides data on Cement Creek, the downstream from the blowout (CC48). Concentrations throughout the first day following the blowout are above historical averages for the copper, lead and manganese. However, the graphs demonstrate a decrease in those concentrations over the 24 hour period.

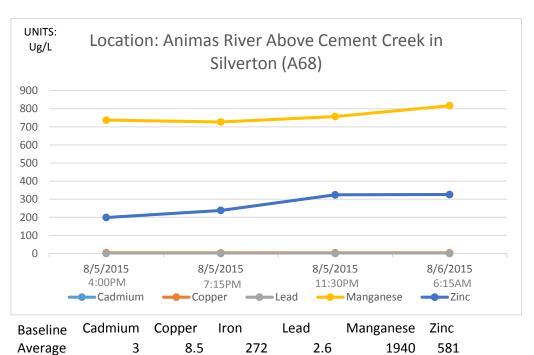
The second graph provides data on the Animas River above the town of Silverton (A68) and above Cement Creek. This graph demonstrates relatively unchanging metals concentrations that are at or below historical averages.
